REHABILITATION OF GRAVITY DAMS. CASE STUDY: CLUCEREASA DAM STRUCTURE ON TARGULUI RIVER, IN THE ARGES DISTRICT.

As a case study, we have chosen Clucereasa water intake dam, a small dam, that uses two pumping stations that ensure providing water for the correct function of the Dacia-Renault car plant and the Mioveni city.

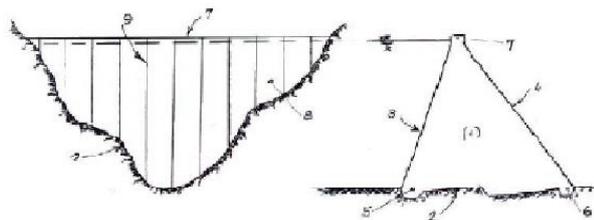
Figure 2. Section in dam

A section in Clucereasa water intake dam is emphasized in Figure 2.

As we speak of Clucereasa gravity dam, the damage has occurred due to outstanding requests that the time transit of major water flows produced, leading to the deterioration of the dam wall until reaching the armature.

Restoration works of the concrete wear layer mean, in fact, cleaning and reconstructing it, using reinforced concrete, dispersed with metallic fibers.
