## SLOPE STABILITY ANALYSIS USING GEO 5 SOFTWARE IN BREBU COUNTY CASE STUDY

Thomas BORBELI

### Abstract

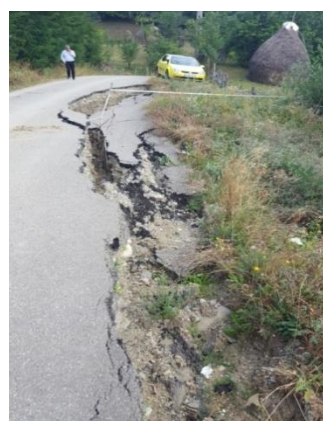
The DC4B communal road was affected by a landslide that caused major traffic issues. This road passes through the village of Pietricioaia and belongs to the Brebu County. This county is located in the central eastern part of the country. This area is part of the Subcarpathian arc that consists of sedimentary formations of Cretaceous and Paleogenic age.

Figure 2. On site perspective after the landslide occurred

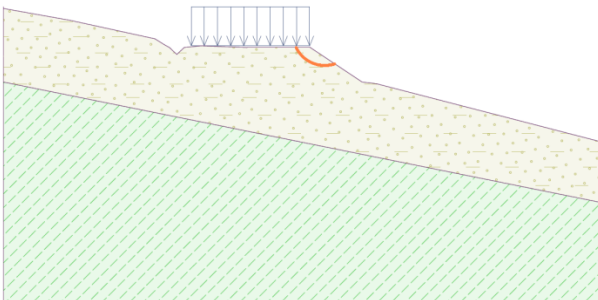
Figure 4. Slip surface Bishop DA1

Slope stability verification (Bishop) DA1  
Combination 1

Utilization: 98.6 %

**Slope stability ACCEPTABLE**

Slope stability verification (Bishop) DA1  
Combination 2

Utilization : 106.1 %

**Slope stability NOT ACCEPTABLE**

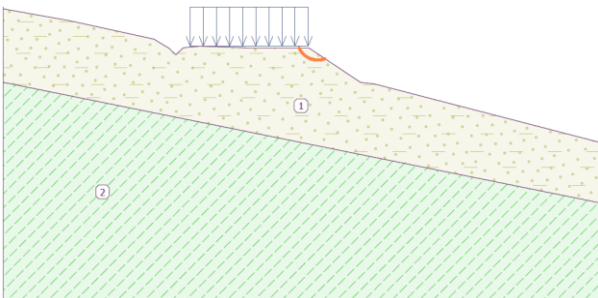
Figure 5. Slip surface Bishop DA3

Slope stability verification (Bishop) DA3

Utilization : 122.8 %

**Slope stability NOT ACCEPTABLE**

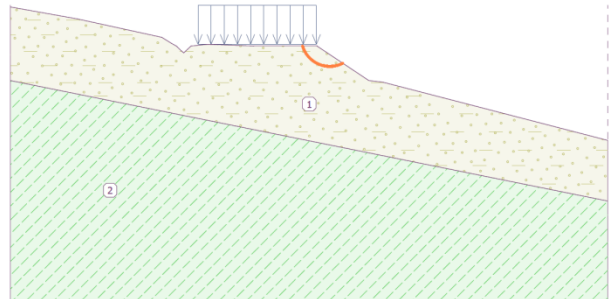
Figure 6. Slip surface Fellenius DA1

Slope stability verification (Fellenius / Petterson) DA1  
Combination 1

Utilization : 116.2 %

**Slope stability NOT ACCEPTABLE**

Slope stability verification (Fellenius / Petterson) DA1  
Combination 2

Utilization : 122.6 %

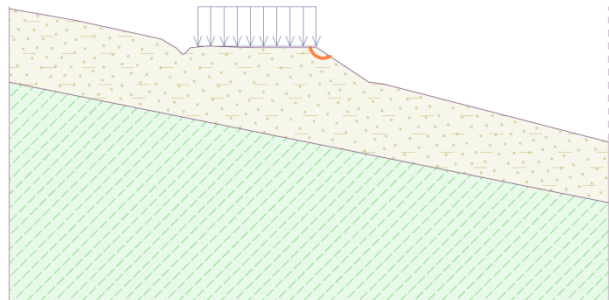
Figure 7. Slip surface Fellenius DA3

Slope stability verification (Fellenius / Petterson) DA3

Utilization : 145.4 %

**Slope stability NOT ACCEPTABLE**

It can be observed that for each of the methods applied, DA3 proved to be the most unfavorable approach. The Fellenius stability test recorded the highest percentage of utilization: 145.4%.

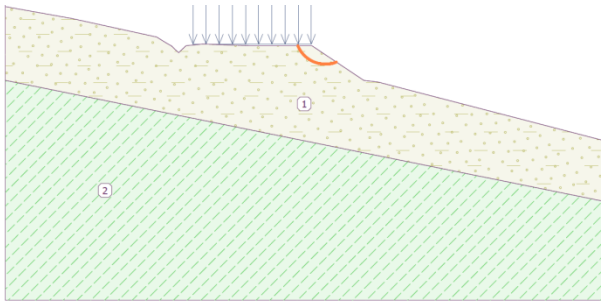
Figure 8. Slip surface Janbu DA1

Slope stability verification (Janbu) DA1  
Combination 1

Utilization: 99.0 %

**Slope stability ACCEPTABLE**

Slope stability verification (Janbu) DA1  
Combination 2

Utilization : 106.8 %

**Slope stability NOT ACCEPTABLE**

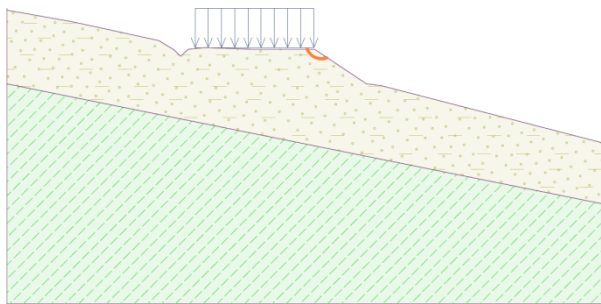
Figure 9. Slip surface Janbu DA3

Slope stability verification (Janbu) DA3

Utilization : 123.4 %

**Slope stability NOT ACCEPTABLE**
