THERMOVISION APPLIED FOR STUDYING THE ELECTROMECHANICAL TRANSMISSIONS OPERATION

Monzer AL ISBER¹

Scientific coordinator: Assoc. Prof. Adrian ROȘCA²

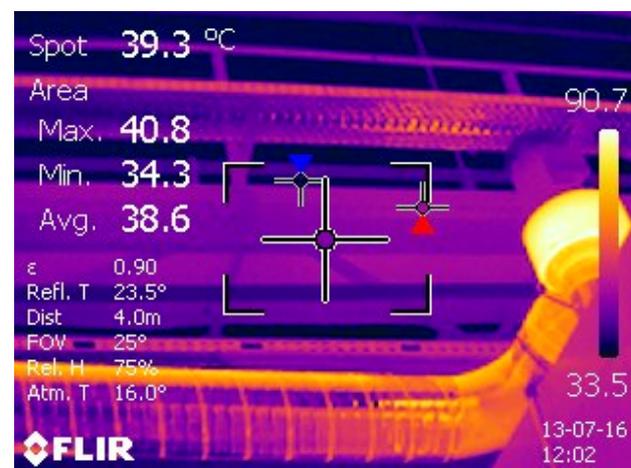
During the experimental researches the heating oven components were evaluated. In Figure 4 is presented the thermograme that shows the correct operation of the oven's ventilation system (90,7°C maximum ventilator temperature) during the preheating process (100°C) for moisture elimination (Al Isber, 2013).

Figure 4. Correct operation of the oven's ventilation system (90,7°C maximum ventilator temperature) during the preheating process (100°C) for moisture elimination

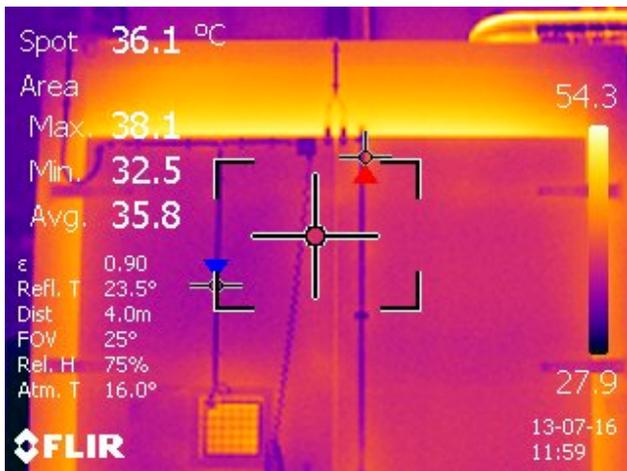
Figure 5. Low quality isolation between the oven's doors, and the oven's frontal side (54,3°C)

But in the same experiment the thermogramme revealed (Figure 5) low quality isolation (54,3°C) between the oven's doors, and the oven's frontal side (Al Isber, 2013).

Therefore the practice internship supervising teacher addressed collegial recommendations to the Impregnation Station maintenance team.

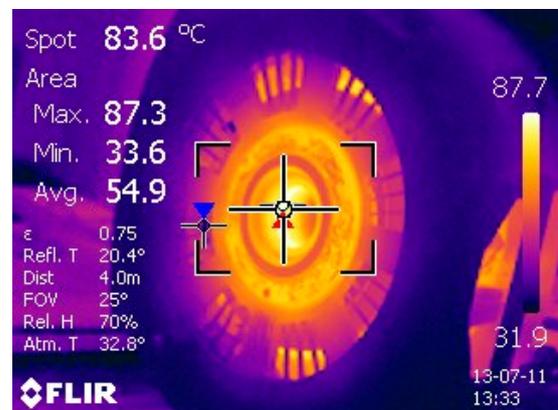
It was observed that even for low rotation speeds the opposite traction side bearing works in high temperatures range 82,9 - 87,3°C (Figura 7). Therefore the practice internship supervising teacher addressed to the technical team collegial recommendations to replace this bearing.

Figure 7. High temperature range 82,9 – 87,3°C of the opposite traction side bearing working in low rotation speeds
