ENVIRONMENT QUALITY IMPROVEMENT AT THE UNIVERSITY OF PITESTI, A FORMER MILITARY SITE

Scientific Coordinator: Lect. PhD. Eng. Mădălina- Cristina MARIAN

University of Pitesti, Faculty of Sciences, Targu din Vale street, no. 1, 110040, Pitesti, Romania,
Phone: +4034.845.31.00, Fax: + 4034.845.31.23

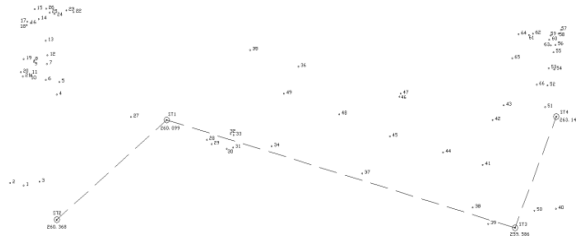
Figure 1. Sketch of the location of stations (sights) and offshoot points

surroundings, for identifying the points within the geodetic network with known coordinates that allows the connection to the Stereo System 79 and provides the necessary precision, the following topographic equipment has been used: GPS SOUTH S86-T and Total Station Pentax W-822NX, using the RTK method - kinematic measurements. The work was done from four stations (Figure 1), due to visibility.

The planimetric survey of the topographic details was done by radiation, the position of the characteristic points being determined. The results were verified through their integration into the tolerances required by the Office of Cadastre and Real Estate Publicity. The writing of the plan with X, Y coordinates was done at 1:1000, with specialized program ACAD, ensuring a high precision of calculations and graphical accuracy. For the classification of the area the ortophotoplan was used. One of the most important criteria for the implementation of the work was choosing the species of plants and landscaping style for the area that has been studied. In order to determine the species of trees and shrubs resistant to environmental conditions and microclimate of the area, a dendrological study was done, in which each species was briefly described with details regarding the ornamental importance, ecological requirements, scientific name, elements about origin and habitat.

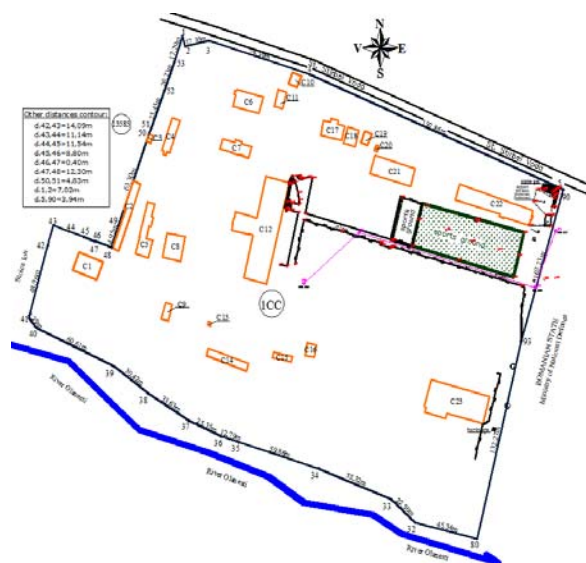
Figure 2. Reporting of the measured points and presentation of the studied site

The area which has been studied has a surface of 72820 sq (Figure 2) and it encloses 23 buildings (Table 1). This area is part of a total surface of 11.8 hectares, cadastral number 14419.

The topographic survey revealed the following existing landscaping: pedestrian alley = 662sq (0.91%), parking = 377sq (0.52%), green spaces = 2136sq (2.93%), sports area = 2591sq (3.56%).

The vacant land area covers a surface of 17122sq (23.51%), with the proposal of getting rid of the metal shack C14. The dendrological study (Table 2) includes the surfaces in the corners of the C12 construction and the surface related to the pedestrian alley, taking into account that for marking the vertical rigid and monotonous lines of the building, groups of trees with columnar crown are planted in the corners. The main aim for the pedestrian alley is the decorative-recreative one. (Sofletea and Curtu, 2008)

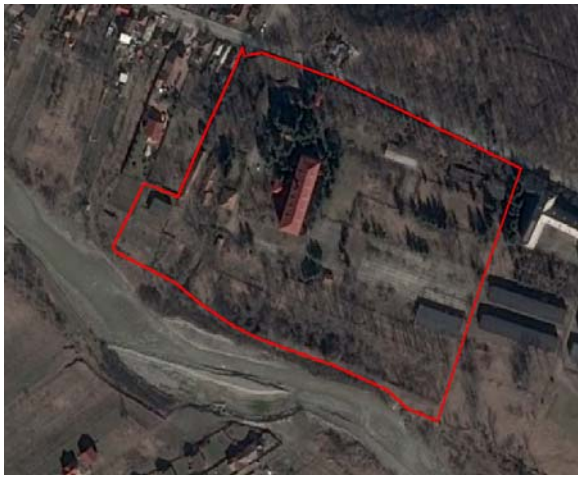
Figure 3. Framing in the area

Framing in the area through ortophotoplan (Figure 3) highlights the southern vacant land.

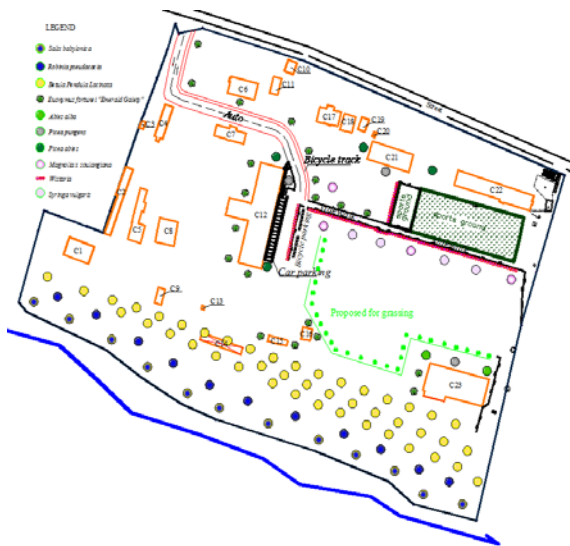
Figure 4. The layout of arrangement

From a functional perspective, by the proposal that was made (Figure 4), the anti-erosion part was ensured by the characteristic of the green

spaces to prevent erosion and degradation of rocks, to retain alluvial materials and to build up the shores of the water courses. From a decorative point of view, the green plantations improved one of the essential principles, namely the harmony, by linking the natural green spaces to the built spaces. In terms of health, the proposed arrangement contributes to the shaping the diurnal temperatures variations, increase of relative humidity of air, oxygen enrichment of the atmosphere, decrease of wind speed. All these features lead to the reduction of fatigue.

The project proposed an arrangement of plants in a natural way so that it fixes the soil and also creates a spectacle of vegetation through foliage, colour and scent. The recommended species of trees and shrubs are resistant to

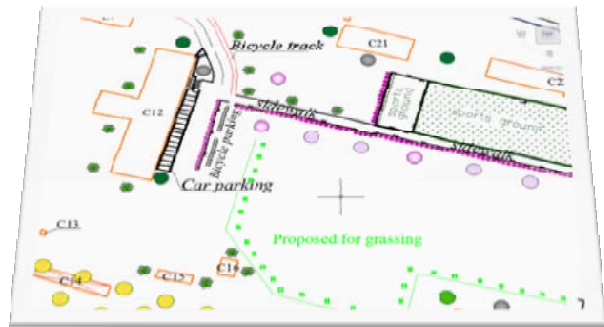
Figure 5. Detail of the arrangement

Redevelopment project included alongside landscape restoration and resolution of access roads the malfunctioning by restoring auto route, resizing car park and the introduction of bicycle lanes and a corresponding parking (Figure 5).
