## WATER QUALITY MONITORING FROM THE LAKES ON COLENTINA RIVER

### **Abstract**

**Key words:** *Colentina River, water quality, surface water*

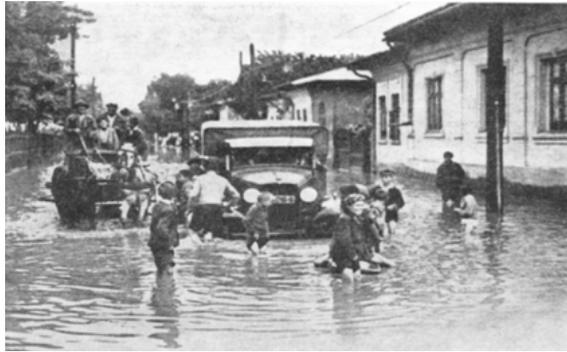
Figure 3. The effects of Colentina's drainage on Bucharest and the surrounding areas (Caranfil, 1963)

In the last 60 years, important hydro-technical projects were implemented along the river's stream, projects that transformed the little mosquito infected river with poor neighborhoods along his sides (Figures 1,2,3) into a chain of lakes with multiple and popular recreations areas. (Giurescu, 1979).

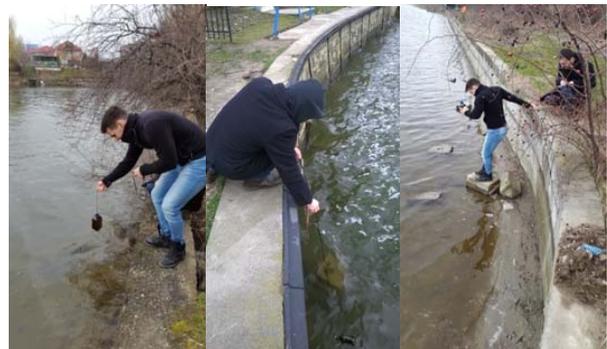
Figure 5. Collecting water samples

For our tests, we collected water samples from the 4 lakes (Grivita, Baneasa, Herastrau and Floreasca), from upstream to downstream, in March 2015 (Figure 5).

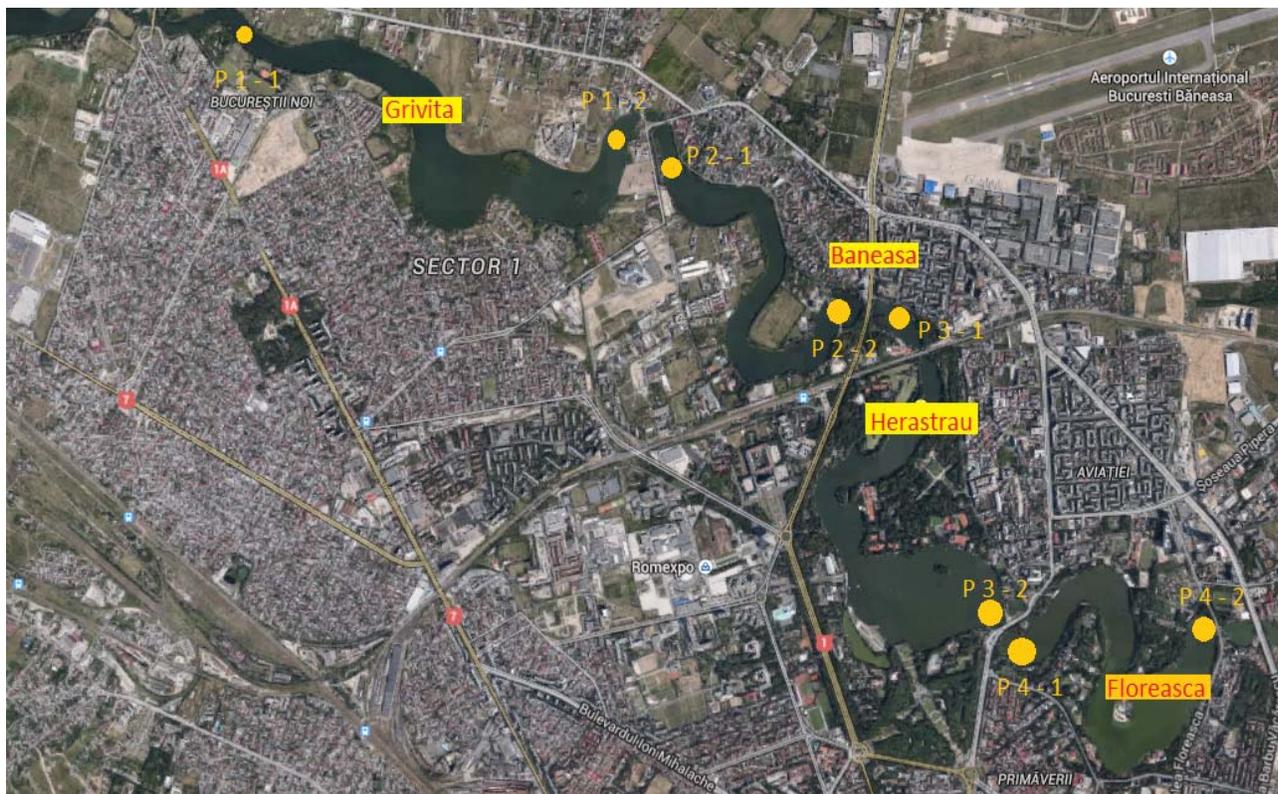
Figure 6. Distribution of collecting points along Colentina River

All the locations from which we gathered the water samples can be found on the Figure 6.

Table1. Details of sampling points

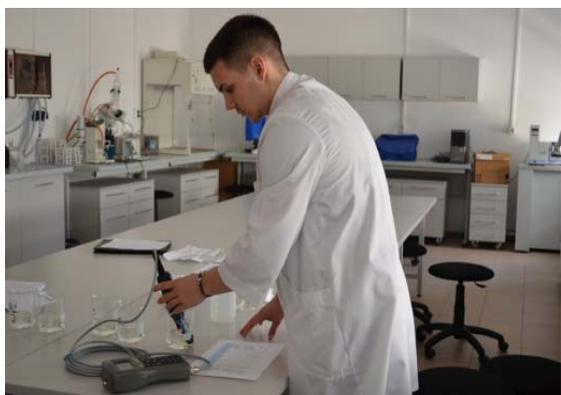
Figure 7. Laboratory measurements of pH, conductivity and dissolved oxygen

Using a multi-parameter device called HANNA HI 9828 equipped with a multi-sensor probe with a dedicated microprocessor we determined the pH, conductivity and the dissolved oxygen, important characteristics in assessing the water's quality.

At first, the probe is immersed in the sample, then easily moved in a circular pattern (2-3 times) until the value displayed by the device stabilizes, followed by the data recording (Figure 7).

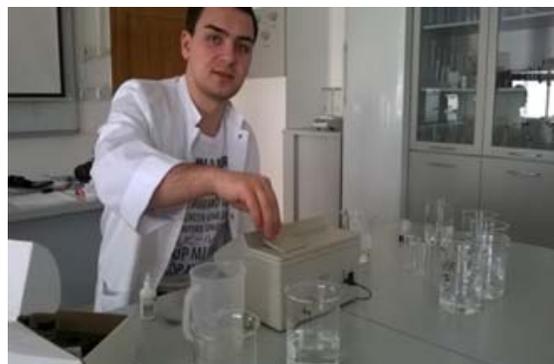
Figure 8. Determining the turbidity with a high precision stationary turbidity meter

The turbidity of the samples was determined using a stationary turbidity meter HI 88713. The device has a high precision, being able to provide accurate values in Nephelometric Turbidity Units (NTU). As steps, we first filled a 10 ml container with one of the water sample and placed it afterwards in the turbidity meter; closed the cover, pressed the "READ" button and after approximately 10 seconds we can record the data written on the display's device (Figure 8).

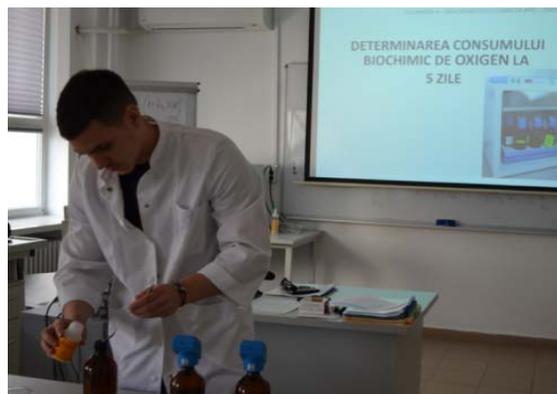
Figure 9. Determining the CBO of the water samples

The biochemical consumption of oxygen is determined with the help of incubation, in dark, at 20°C with the BDO5 Velp Scientifica device together with the proper accessories (Figure 9).

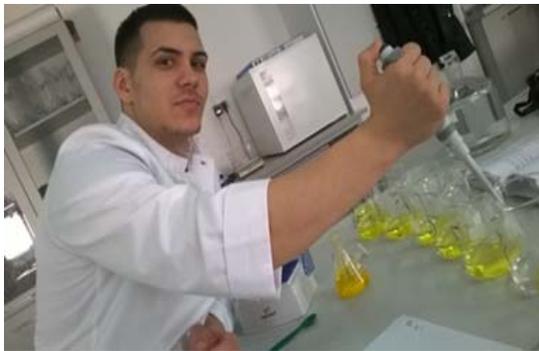
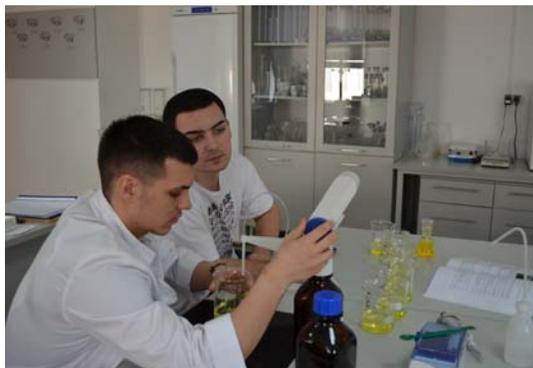
The chlorine determination was possible by using the Mohr methodology.

The technique uses the titrimetric evaluation of the chlorine content within the water and it's a direct process for finding the chlorine concentrations between 5 mg/l – 400 mg/l. The method is based on the reaction between the chlorinate ions and the silver ions which leads to the appearance of an insoluble silver chlorine (Figures 10, 11).

Figure 10. Determining the chlorine using the titrimetric evaluation

Figure 11. Determining the chlorine using the titrimetric evaluation
