STUDIES REGARDING THE DETERMINATION OF GEOMETRIC DIMENSIONS AND GEOMETRICAL DEVIATIONS COMPARING WITH THE PROJECTED ONES FOR FUEL TANKS

Key words: fuel tank, geometrical dimensions, deviations, deformations, measurements.

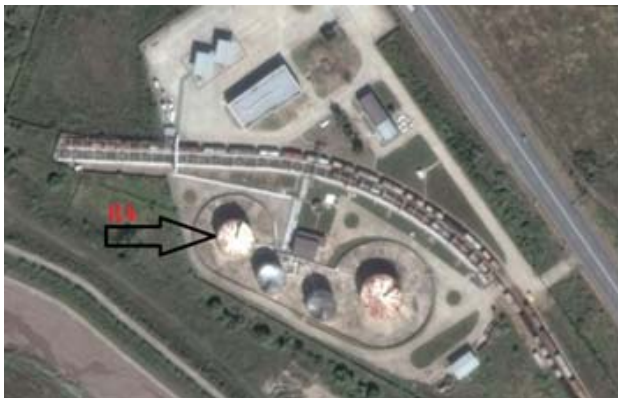
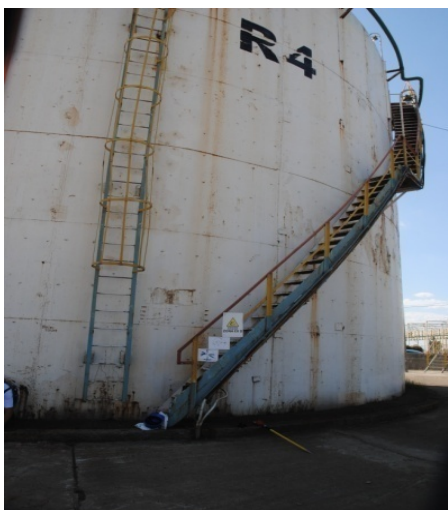
Figure 2 Fuel tank R4

Body of property that has the tank R4 (Figure 2) subject to topographic measurements in order to determine the geometric dimensions and geometrical deviations is owned by Rompetrol Warehouse Craiova , Dolj County.

During field reconnaissance it was identified the site of the 3150 m³ R4 tank and station points were set so that they can perform in all necessary measurements to determine the geometric dimensions and geometrical deviations requested. For the measurements were determined following points:

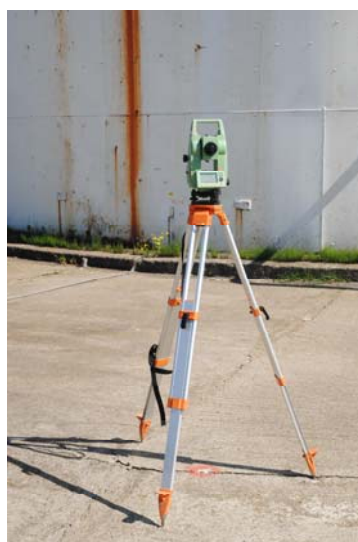
Figure 3. Total station Leica TCR 1205

To realise the traverse measurements and sideshot for external details, it was used a total station Leica TCR 1205 (Figure 3), for sideshots representing details inside the tank, it was used a total station Leica TC 410 C, and for determining the coordinates of starting, closing and guidance of the traverse used ProMark2 Ashtech GNSS receivers type. Given the location of the tank R4, i.e. a retention tank with high walls allowing visibility only inside it was established as a method for determining the coordinates of the station points, closed traverse on the starting point.

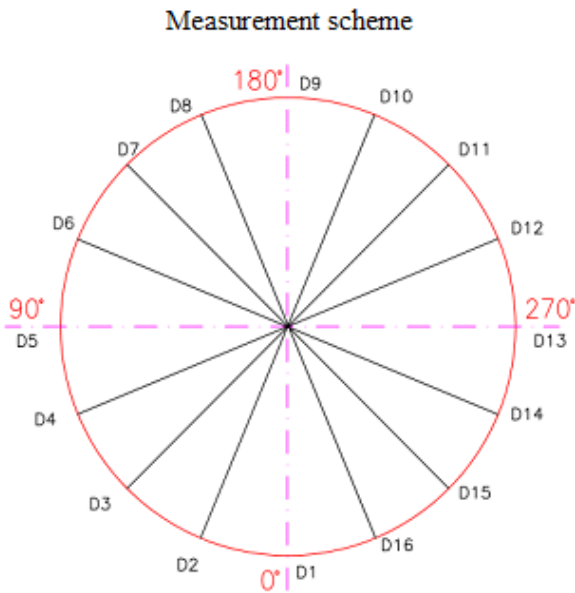
Figure 6. Offset from verticality and the height difference between the top and bottom

Verification of the geometry of the tank shell R4 - According to the Standards R4 tank C220 offset from verticality and the height difference between the top and bottom (Figure 6) must be less than ± 60 mm (tanks manufactured by rolling with a volume of 2000 ... 5000 m³) .

From the measurements sheet it is found that the deviation from verticality is in some measure points above the permissible limits according to Table 2.

1. A negative deviation: the distance between the perpendicular lower point of welding of the sheath to the cap and the horizontal plane of the container is in its interior. Positive deviation: the distance between the perpendicular lower point of welding of the shell with the cover of the container and the horizontal plane is situated outside it.
