## RESEARCH CONCERNING GULLY EROSION EVOLUTION ON AGRICULTURAL LANDS

**Bogdan DUMITRU<sup>1</sup>, Catalin BOTE<sup>1</sup>**

**Scientific Coordinator: Prof. Sevastel MIRCEA<sup>1</sup>**

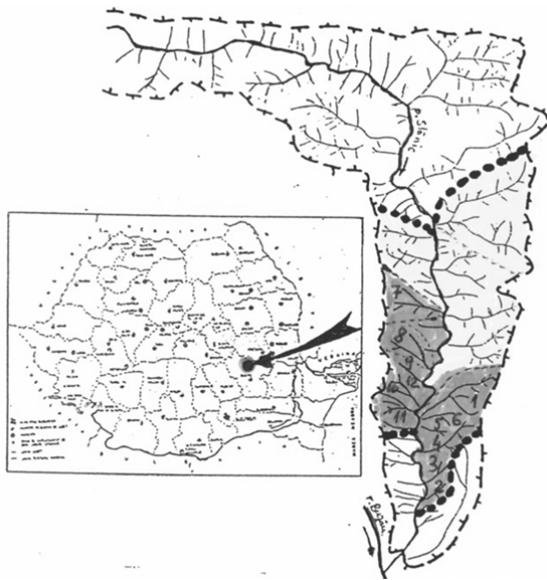
Figure 1 Sketch of the studied area, Slanic/Buzau, Sub-Carpathians Curvature region, Buzau County, Romania

represented by 65 km found mostly in the Subcarpathians Curvature. Slanic River represents the Eastern boundary of Muntenia's Central Sub-Carpathians and separates Vrancea Mountains from Buzau's Plain. Buzau area represents an interest to our field of activity and continuously research because there are recorded the most significant soil losses in the country. In Buzau County it has been inventoried a gully erosion network of about 1,000 km, that represents about 1,000 hectares of agricultural lands (Mircea, 2000, 2008). Having in view the complexity of the land degradation processes in the Slanic Valley watershed, a huge interest is represented by several of the sub-watersheds, being mainly located in the low and medium third parts of the watershed, which were taken into study in this paper. In our study we have made a topographical survey on the gully from the Tatarului Valley, which is located on the right side of Slanic River (Figures 1 and 2).

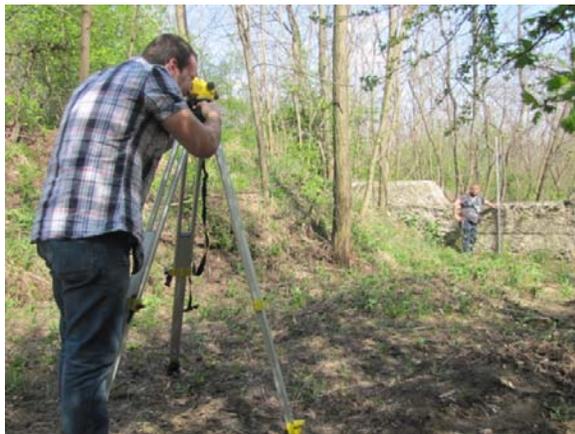
Figure 2 Topographical survey on the gully from the Tatarului Valley, Sub-Carpathians Curvature region

Its evolution would have been much greater in time if the gully and its side walls well as the surroundings wouldn't have been forested with acacia species. The acacia trees have spread their roots on the entire perimeter, which caused in this way a slower evolution of the gully, as it can be seen in Figures 2.

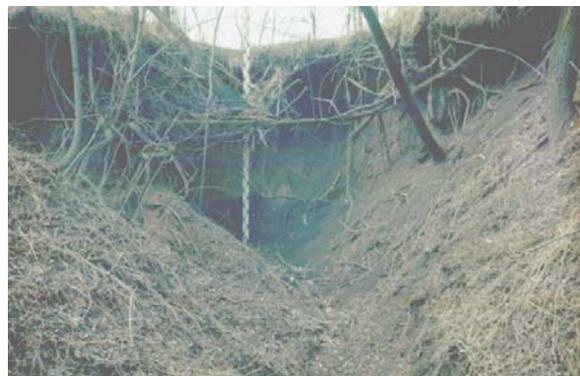
Figure 3 Gully's headcut of Tatarului Valley, Sub-Carpathians Curvature region, Buzau County, year 1997

volume necessary to combat soil erosion may vary from 20% to 60% depending on the importance of the objectives that must be protected. The gully from Tatarului Valley has a concrete check-dam of 3.5 meters high, which was identified at the distance of 32 meters from gully's headcut (Figures 3 and 4). This check-dam was not silted on its first 1.6 meters in the year 1997, and today - because of its drain holes that height has grown to almost 2 meters. In those seven years the length of this gully grew up upstream rapidly from 32 to 43 meters (Figures 3), despite the fact that the discharge of the gully's headcut has been decreasing a little bit in time.
