## EVOLUTION OF PRIVATE AREAS IN THE NORTH SIDE OF HERĂSTRĂU PARK

Raluca Ioana MIHAI, Adina Maria VAIDEȘ

### Abstract

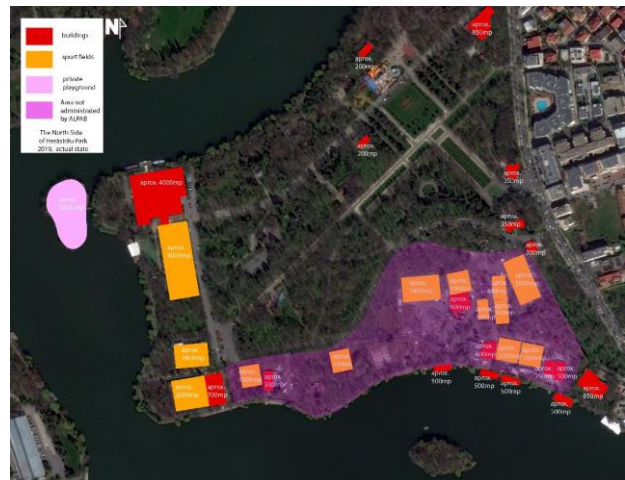
Figure 3. Refined aerial view of the private areas from the North Side of Herăstrău Park - 2019

(source: authors – analysis over satellite images from Google Maps)

Legend: red – buildings; orange – sport filed; light purple – private playground; dark purple – area not administrated by A.L.P.A.B.

Legend: red – buildings; orange – sport fields. Nowadays, 10 hectares from North-East Side are no longer administrated by the Administration of Lakes, Parks and Recreation of Bucharest (A.L.P.A.B.) (Popescu - Criveanu et. al., 2018). Most of the pontoons from the east side of the peninsula have been transformed into private terraces. These private constructions tend to be as close to water as they can, in order to manage a small business by preventing people's access to the water (Figure 3). Thus, a significant amount of public space is lost due to the constant growth of built areas.

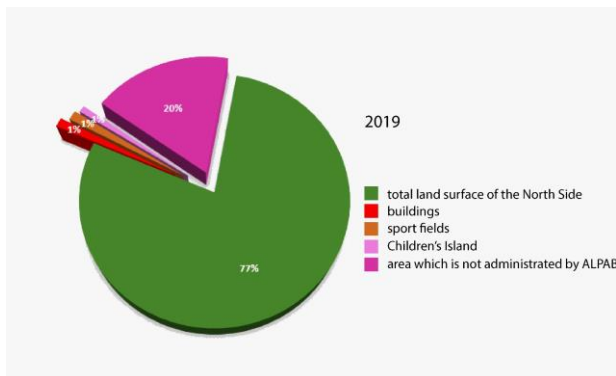
Figure 5. The actual state of the North Side of Herăstrău (source: authors)

Referring only to the North Side of Herăstrău, we translated the private built area into 23% of its total surface (Figure 5). Almost a quarter of this zone is represented by built areas, sport fields and private playgrounds. The private enclave which is no longer administrated by A.L.P.A.B remains the most significant amount of lost land surface.
