## MONITORING OF BRIDGE OVER THE DANUBE-BLACK SEA CANAL AT AGIGEA

Andrei Iulian MIHALACHE, Iosua Andrei PANTEA, Catalina Georgiana LEAHU

Politehnica University of Timisoara, Faculty of Civil Engineering, Department of Land Measurements and Cadastre, 2A- Traian Lalescu str., Timisoara, Romania email: andreimihalache01@gmail.com

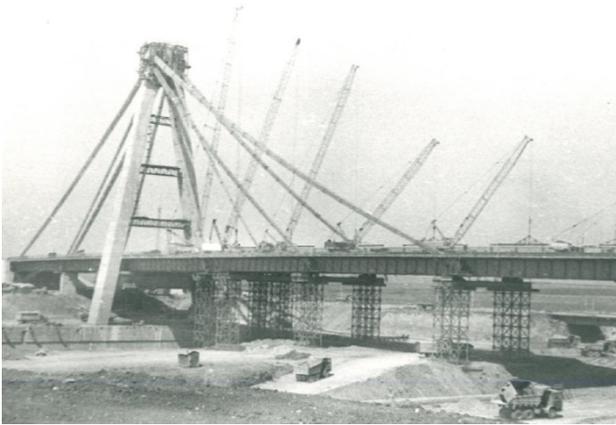
Figure 4. Construction of the bridge

Analyzing the technical documentation which led to the implementation of the project Agigea, it was noted that two years after the commissioning of the bridge cable-stayed

respectively in May of 1985, was made an adjustment of the tensile stresses in the beams.

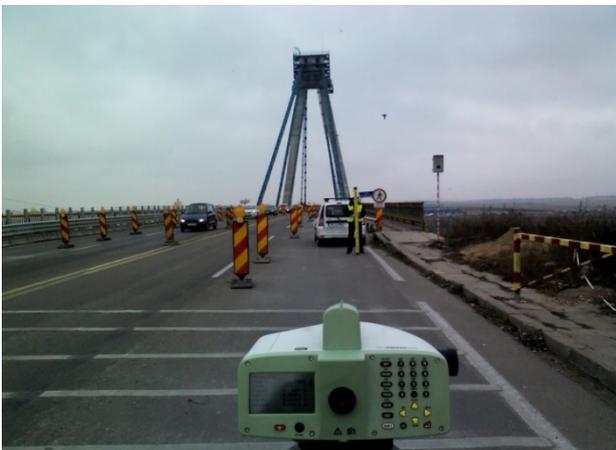
Figure 5. Measurements realized in our time

By using real-time deformation observations when performing measurements, designers or the construction team shall receive information on the deformations of the construction, data that can be immediately compared with those established in the project, enabling in this way the consideration also of other charging schemes, if the deformation limits given in the project are not respected.

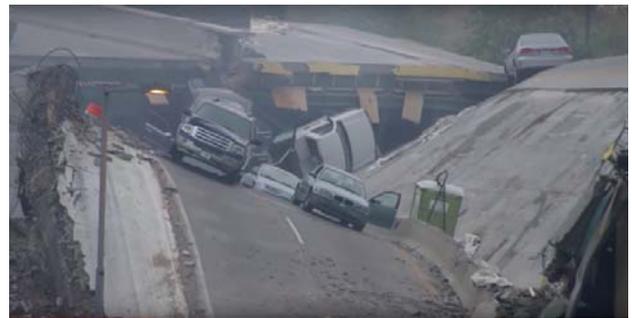
Figure 6. Bridge colaps

a) loads due to the influence of external disturbing factors, such as weather and / or tectonic (wind, temperature, precipitation, earthquakes);

b) load from weight of the structure (uneven subsidence of the bridge leading to the emergence of strains);

a) failure due to design (structure as a whole, including foundation or parts of the structure can not take actions in accordance with local design criteria);

b) failure due to exceeding load levels (local loading conditions exceed the anticipated loads);

c) failure due execution of construction (improper execution of the construction, poor quality of construction materials);

d) failure through damage (damage successive result of the construction, lack of maintenance program)
