## SLOPE STABILITY ANALYSIS USING GEO 5 SOFTWARE IN BREBU COUNTY CASE STUDY

Thomas BORBELI

### Abstract

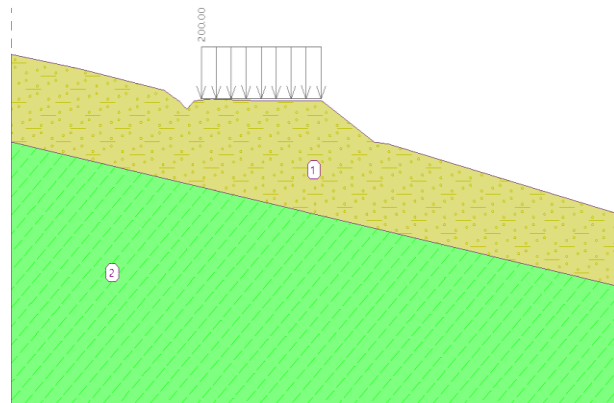
Figure 3. Overview of the model

Two layers were taken into account for analysis. Their geotechnical index parameters and an overview of the model can be seen below. A distributed load of 200 kPa was assigned on the road platform.

Brown clay sand with light green interlaces and sandstone fragments	
Unit Weight $\gamma$	17.49 kN/m <sup>3</sup>
Angle of internal friction $\emptyset$	24.00 °
Cohesion of soil c	23.40 kPa

Grey clayey silt with sandstone fragments, with carbonized roots	
Unit Weight $\gamma$	18.88 kN/m <sup>3</sup>
Angle of internal friction $\emptyset$	17.00 °
Cohesion of soil c	27.30 kPa
