EARTHQUAKES AND THEIR CONSEQUENCES ON BUILDINGS

Sânziana BITULEANU, Cosmin - Bogdan DANCIU, Sebastian SANDU

Scientific Coordinator: Assoc. Prof. PhD Eng. Claudiu - Sorin DRAGOMIR

Key words: irregular buildings, seismic action, seismic instrumentation, structural assessment.

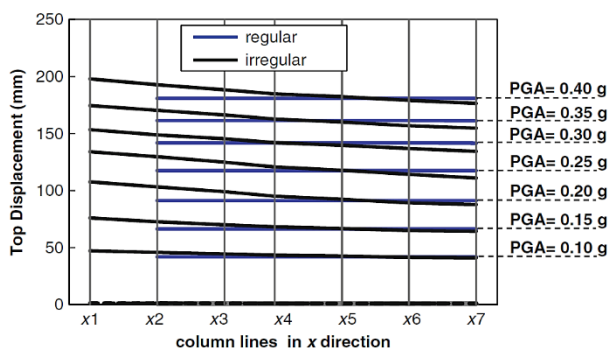
Figure 3. Top story displacement at each column line

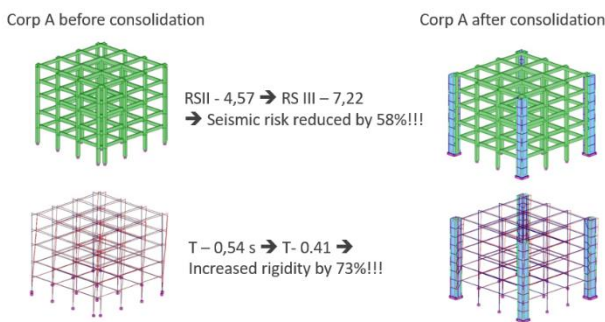
Figure 9. Spatial deformation of corp A after an earthquake, before and after consolidation

Eccentricity can provide a global picture of the torque applied to the structure in question, as well as the structural interventions required to reduce the effects. The building's modelling and structural analysis were performed with the ROBOT Autodesk program, and the dynamic characteristics determined by temporary seismic instrumentation of the structure using GMS-18 equipment and GeoDAS software have been used as input to match the structural model.

According to the structural analysis, a 73% improvement in rigidity was achieved by consolidation solutions with marginal pillars (Dragomir et al., 2019).

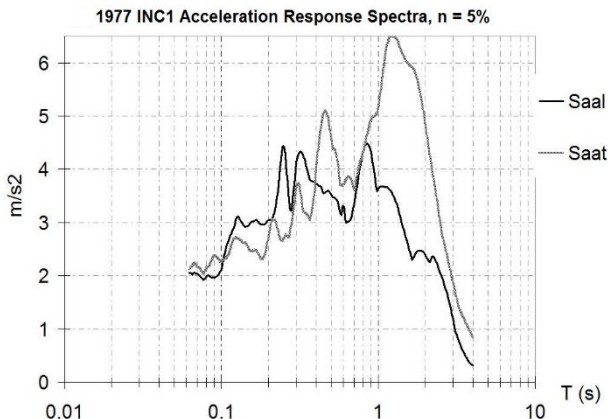
Figure 11. On March 4, 1977 – first recorded data of engineering concern to INCERC

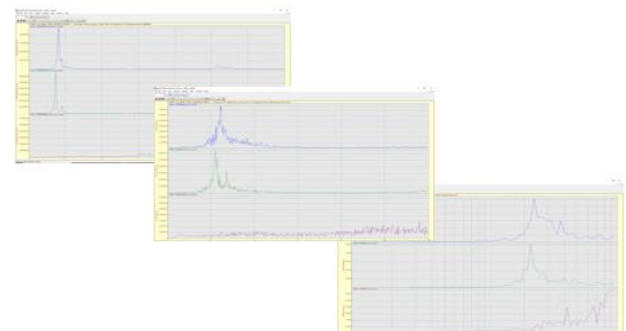
Figure 14. Own periods of body A identified by the processing and analysis of the registration from April 5, 2021

Reduced oscillation periods results in increased rigidity.

Date	Execution type	Oscillation direction	
		Transversal	Longitudinal
3.12.1986	microseisms	0.62	0.57
19.11.1990	microseisms	0.53	0.43
11.10.1996	microseisms	0.50	0.44
11.10.1996	Explosion-maximum excitation	0.57	0.50
11.10.1996	Explosion-free vibration	0.53	0.44
13.02.1998	microseisms	0.42 – 0.44	0.40 – 0.42
21.12.2009	microseisms	0.35	0.42
02.03.2012	microseisms	0.38	0.42 – 0.44
05.04.2021	microseisms	0.40	0.42
